PETER HUGHES
PROPERTY INSPECTIONS

Defect Inspection Report
To AS4349.0-2007 Inspection of Buildings General Requirements

Property Address: 81 Quia Station Rd Emerald Hill 2380

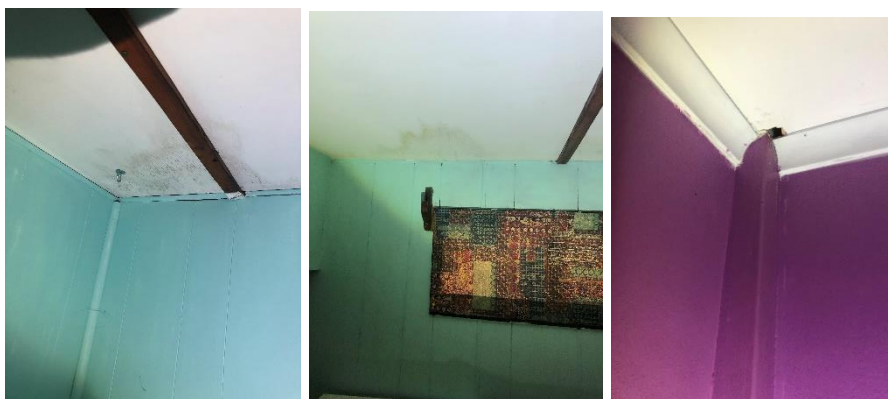
Detached Buildings / trailer: Defects/Safety Hazards found were moisture stains in ceiling along back wall. Water disconnected to toilet in trailer. Flooring damaged and incomplete. Silicon / grout deteriorating in shower recess on concrete slab. Holes in wall lining. These defects can create structural damage. Consult with licensed contractors for repair.

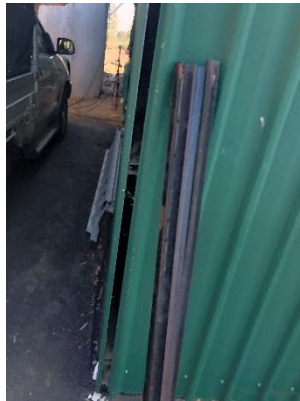
Garden Sheds and Fences: Defects/Safety Hazards found were flashing incomplete on large shed. This may create waterproofing defects. Consult with a licensed contractor for repair.
